# RESTORATION OF HISTORIC TIMBER STRUCTURES: THE GREAT ROOF STRUCTURES OF THE CATHEDRAL OF VERCELLI

Clara Bertolini<sup>1</sup>, Gianoreste Biglione<sup>2</sup>, Luciana Cestari<sup>3</sup>, Germana Corradino<sup>4</sup>, Alan Crivellaro<sup>5</sup>, Daniele De Luca<sup>6</sup>, Tanja Marzi<sup>7</sup>, Pia Panosch<sup>8</sup>, Riccardo Pasquino<sup>9</sup>

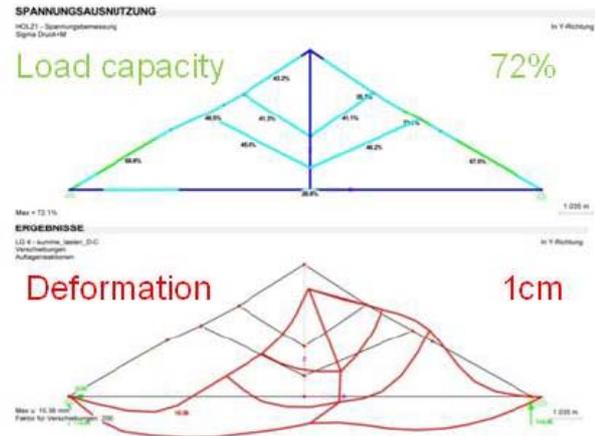
**Figure 4:** Results for the load case D-C (highest loads)

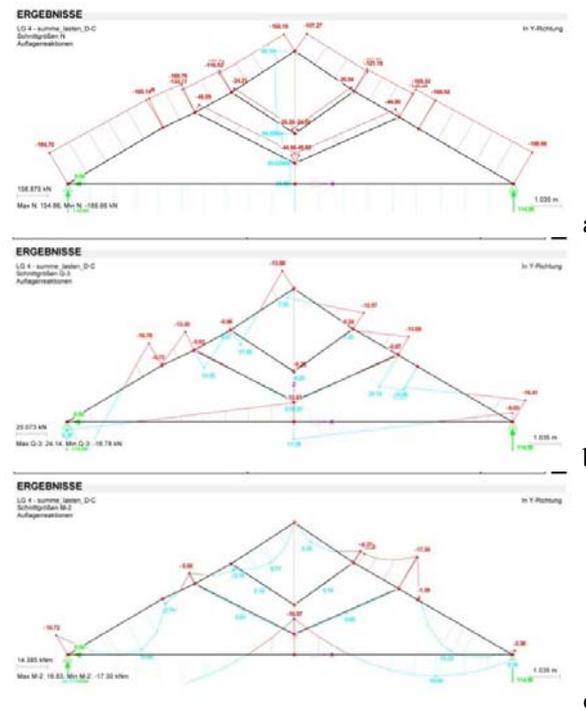
**Figure 5:** Axial force working on the beams (a); shear force working on the beams (b); axial force working on the beams (c).

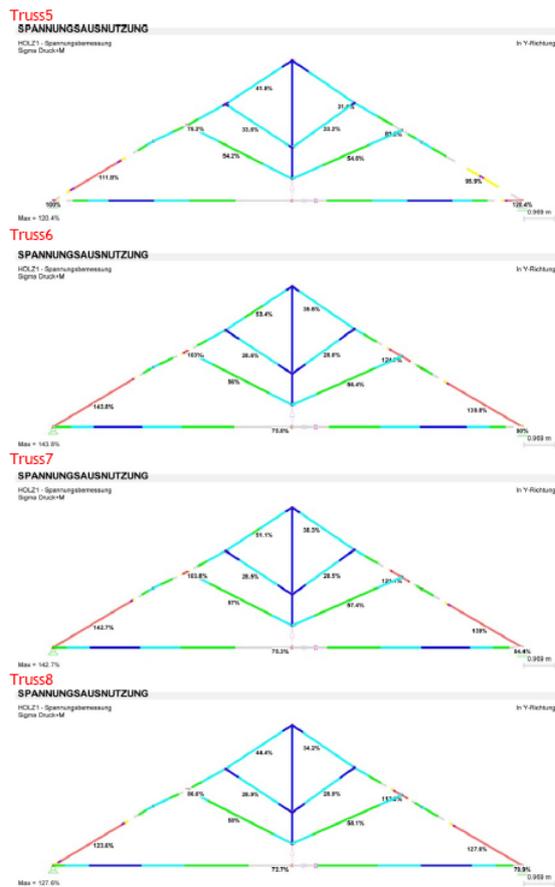
**Figure 6:** Structural models reporting decays and defects of the components (stress in the lower part of the rafters is generally a too high)

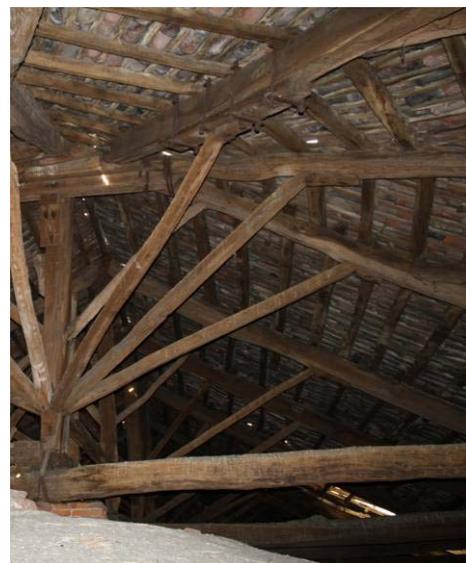
In the specific case of the Cathedral of Vercelli, the temperature during the days of the survey was of 3-5°C and the air relative humidity was 80%. In these thermo-hygrometric conditions, wood assumes an equilibrium moisture of approximately 16%. Furthermore, the high value of environmental moisture content has to be connected with the water leaking that are clearly observable due to traces and spots visible on some elements.

**Figure 7:** Elements of the roof timber structure over the apse of the Cathedral of Vercelli

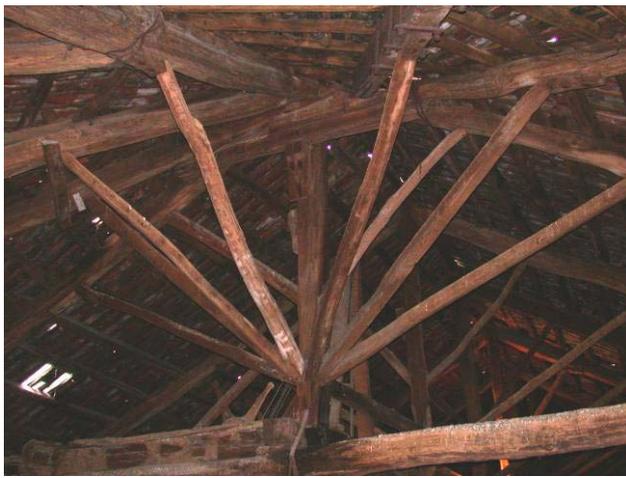
In general, tie-beams are more decayed than rafters. This is probably due to material (i.e. concrete, pieces of tiles and bricks) that fills the space between the heads of the trusses and the masonry. This material becomes wet after rainwater leaking and provokes a high moisture content in wood that is therefore more subject to xilofagus fungus attack.

**Figure 7:** Elements of the roof timber structure over the apse of the Cathedral of Vercelli

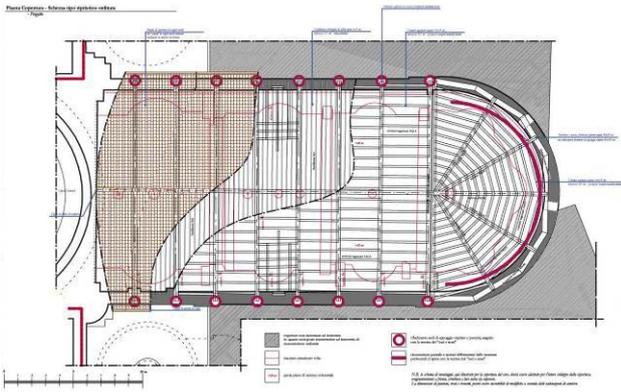
**Figure 9:** Plan of the presbytery-choir. Scheme of the restoration project for the roof structure.

With the aim of bringing back thermo-hygrometric conditions of wood below the limit that is favourable to fungus attack, is indicated to facilitate air circulation around the wooden parts inside the masonry, so that it will be possible to reach better moisture conditions.

It is also advisable an accurate cleaning of the horizontal timber elements with the removal of dust and various deposits.

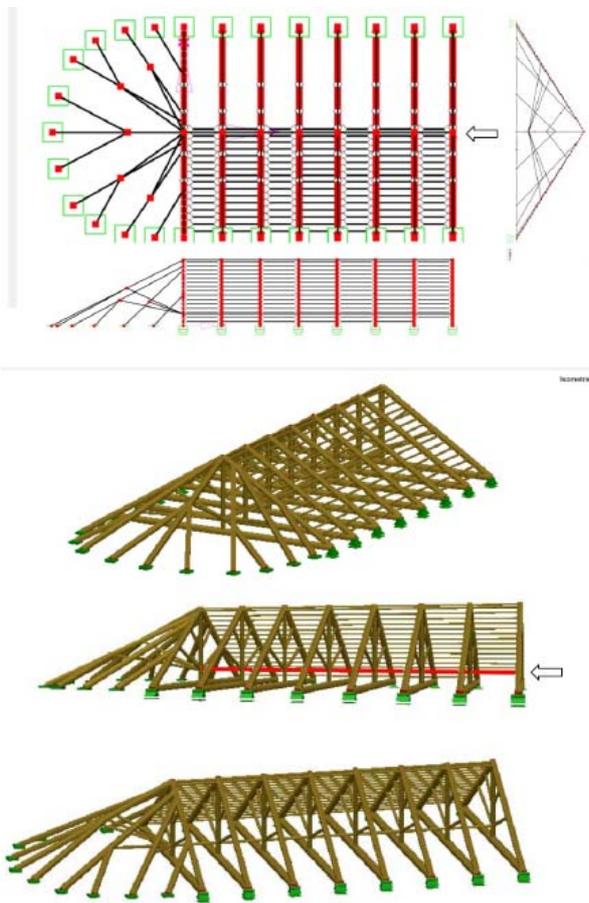
**Figure 10:** Sketches of intervention proposal
